CONTENTS

No. 3

Issue 3.

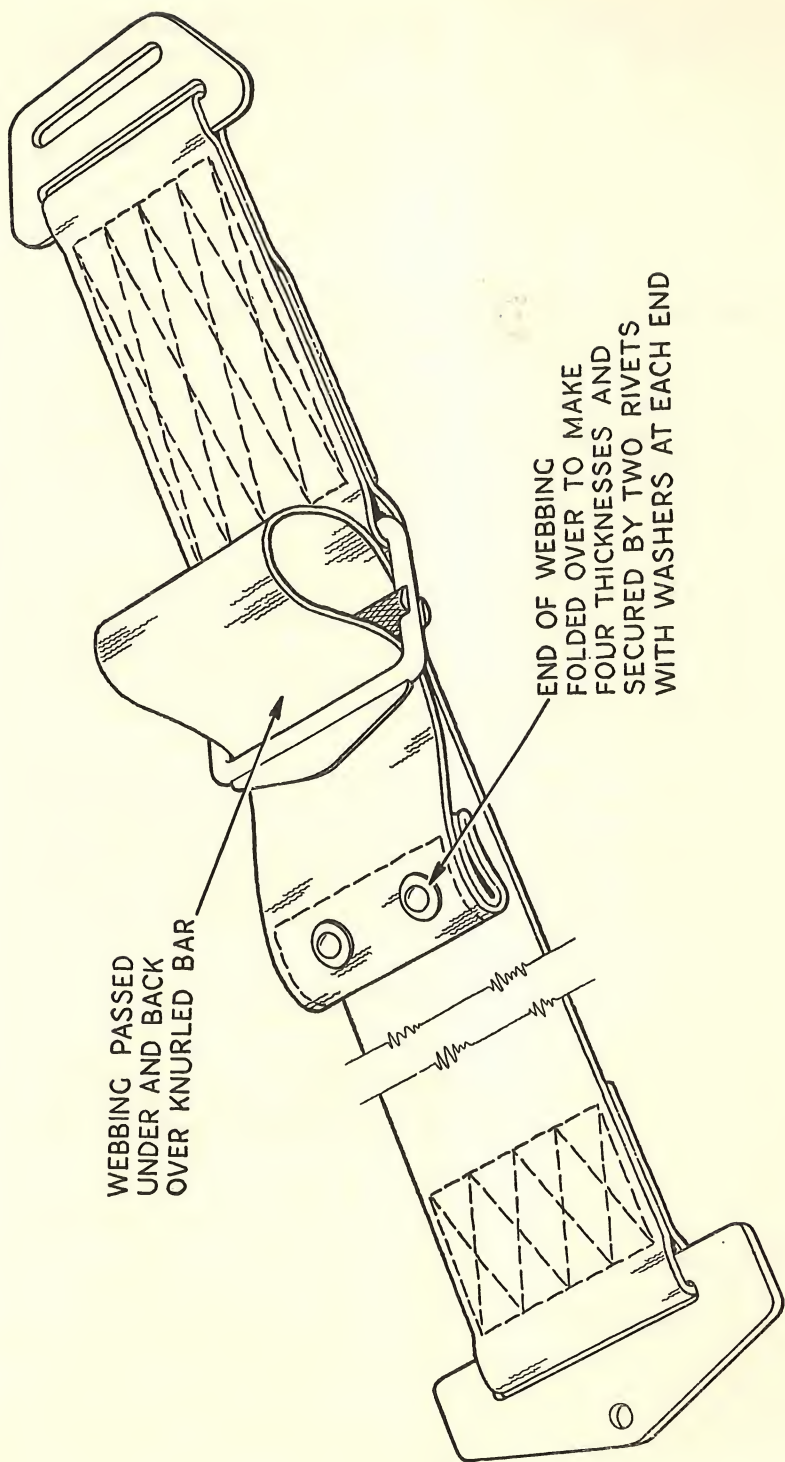
WEBBING PASSED
UNDER AND BACK
OVER KNURLED BAR

END OF WEBBING
FOLDED OVER TO MAKE
FOUR THICKNESSES AND
SECURED BY TWO RIVETS
WITH WASHERS AT EACH END
